Real Estate Journal

Swig Equities completes repair and restoration of coppered eagle cupola at 324,000 s/f 48 Wall Street

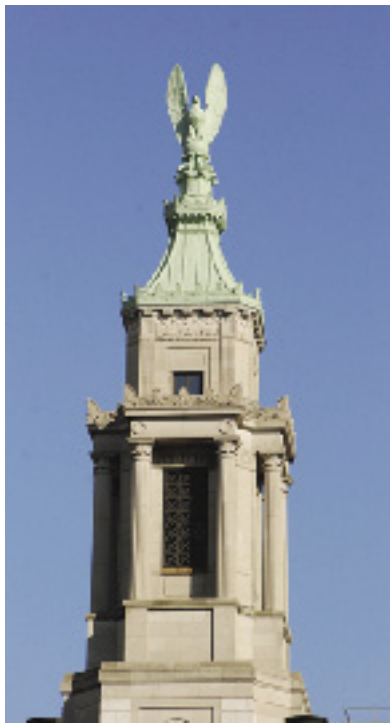
#1 Coppered eagle cupola

Prior to the cupola restoration, a thorough conditions assessment was carried out, documenting the existing condition of the cupola. The investigation revealed the development of cracks in the seams of the copper sheathing, displacement of the copper cupola base due to rusted steel, pitting of the existing copper sheathing due to deterioration of the existing gray coating, and crushed ornamental elements, which had allowed water to infiltrate and deteriorate the internal supporting steel structure of the cupola, including the steel brackets securing the copper eagle, and the cement fire-proof encasing that surround the steel structure. In an effort to address the structural and material failure issues and to preserve the historic fabric of the copper cupola and eagle, the following work was performed: the copper sheathing at the cupola was cleaned and recoated to match the copper green patina of the eagle with a reinforced elastomeric coating which also sealed all of the open seams and pit holes; the copper fascia at the cupola base was fully restored, flashing reintroduced, and re-secured into the existing substrate before applying the coating; existing crushed ornamental elements were restored; the interior steel supports were inspected and covered with new fireproofing material; the copper eagle was dismantled in order to gain access to replace the rusted steel brackets and then re-assembled and coated to match the rest of the cupola. Through a cross-disciplinary approach integrating both historic and modern architectural and construction practices, advanced technologies, conservation science, restoration craftsmanship, and architectural history, the cupola was able to be restored and the historic integrity of the cupola was able to be maintained.

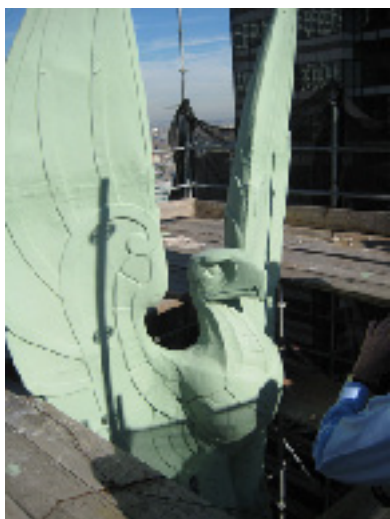
#2 Coppered eagle cupola
